Property Inspection Report

111 3rd Street, Any City, IL, 12345

Date And Time Of Inspection: 5/17/2021 1:00 PM

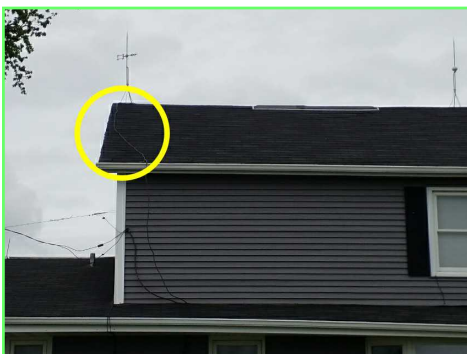
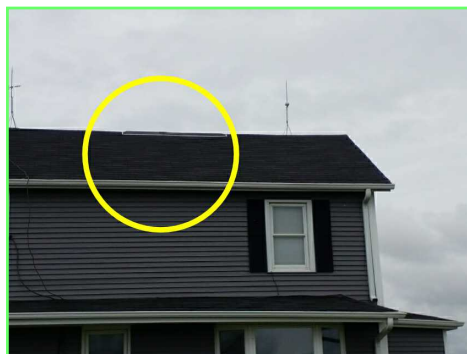
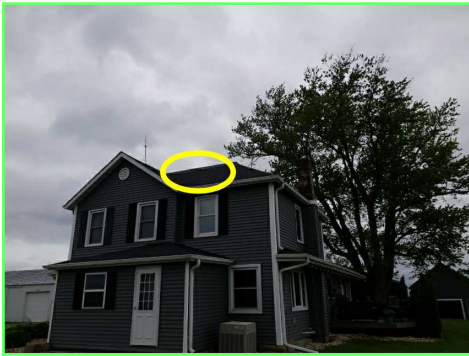
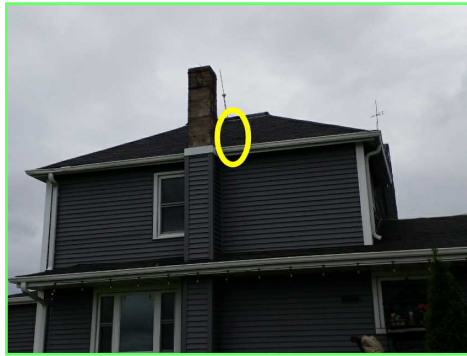
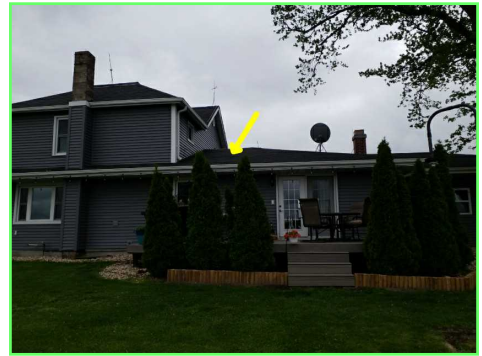
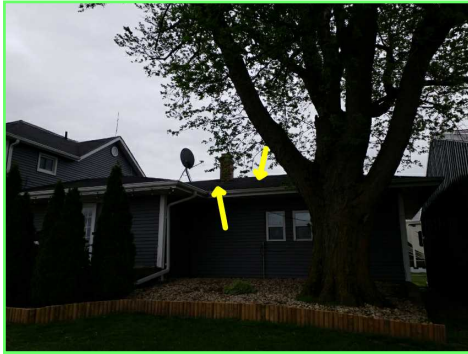
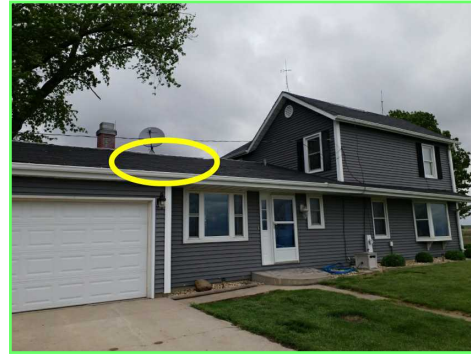
5.2. Missing shingles were observed and require repair.

Missing Shingles

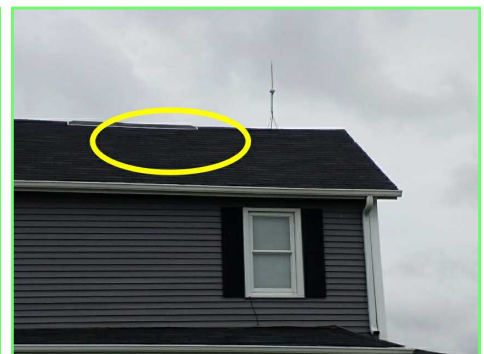
5.1. Exposed nail heads on the shingles were observed. They should be sealed to help reduce the risk of leaks.

Nail Heads

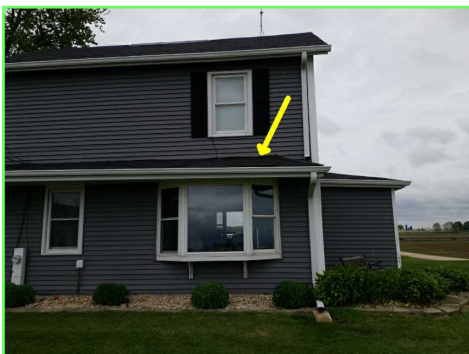
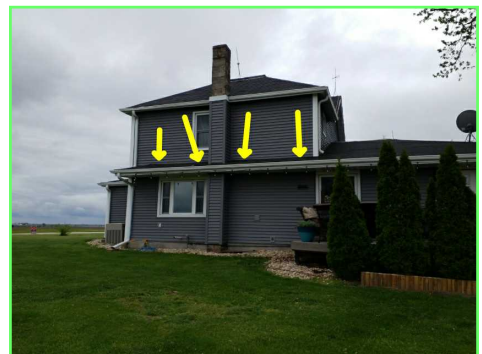
7.2. Flashing has pulled away from roof surface where the siding meets the roof in different areas.

Flashing Pulled Away

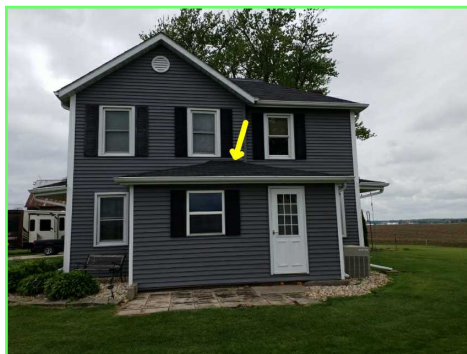
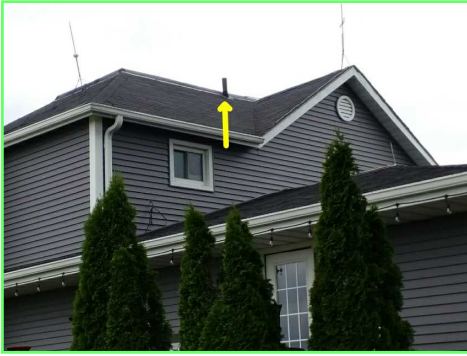
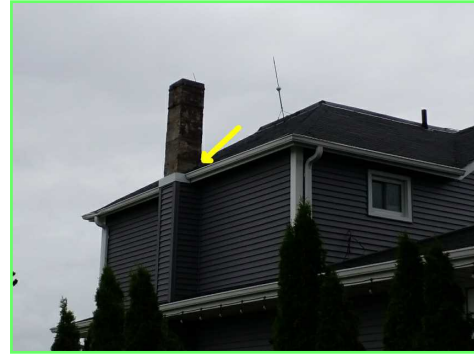
7.1. One or more roof penetrations have been sealed with tar or mastic. Leaks may develop over time as the sealant deteriorates. The penetrations will need to be diligently monitored for leaks and periodically re-sealed. Replacement of the flashing is a better alternative and is recommended.

Tar/Mastic

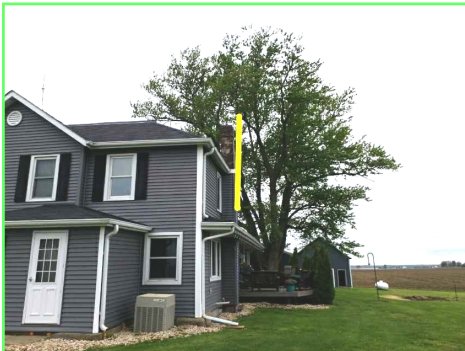
- 8.1. A rain cap and vermin screen should be installed on the masonry chimney.
- 8.2. The masonry chimney showed evidence of cracking. This should be investigated further by a masonry specialist.
- 8.3. The masonry chimney is out of plumb. The chimney flue should be checked for damage. Damaged flues can be **unsafe**. This should be investigated further by a masonry specialist and make repairs as necessary.

Chimney Is Out Of Plumb

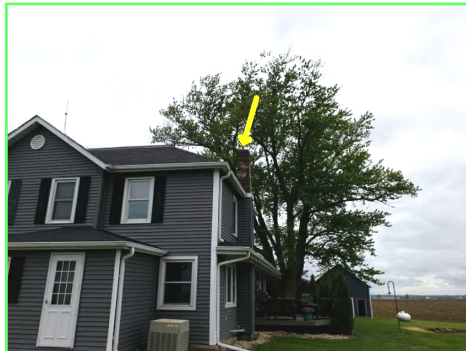
No Rain Cap Or Vermin Screen Present

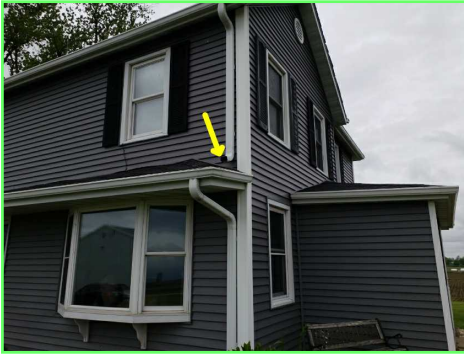
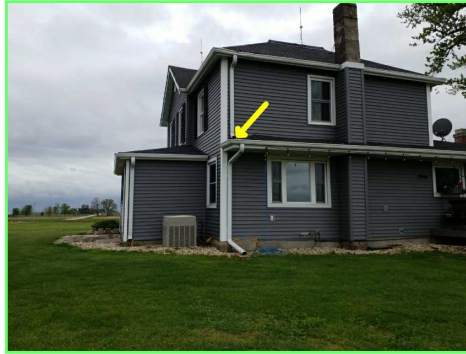
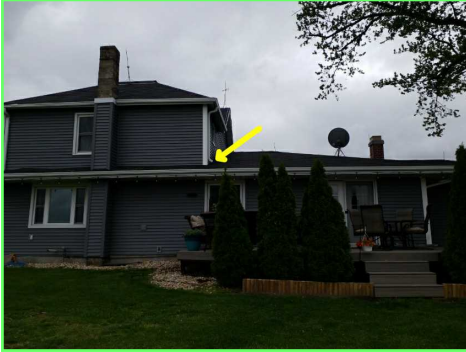
- 9.1. The downspouts should discharge water at least five (5) feet from the house. Storm water should be encouraged to flow away from the building at the point of discharge.
- 9.2. Damaged gutters should be repaired or replaced to avoid spilling roof runoff around the building, a potential source of water entry and/or water damage.
- 9.3. Downspouts that discharge onto the roof should be extended to discharge directly into gutters below. This condition, if left unattended, can result in premature deterioration of the roofing material.

Discharges Onto Roof

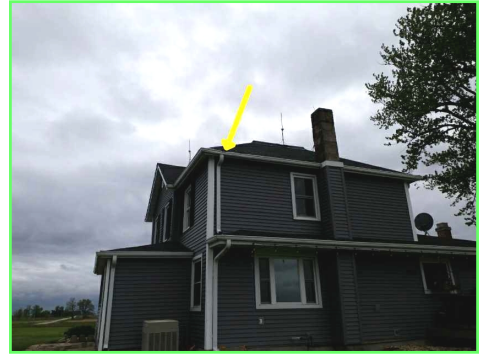
Page 14 Item: 9	Roof Drainage System	<p>9.2. Damaged gutters should be repaired or replaced to avoid spilling roof runoff around the building, a potential source of water entry and/or water damage.</p> <p>9.3. Downspouts that discharge onto the roof should be extended to discharge directly into gutters below. This condition, if left unattended, can result in premature deterioration of the roofing material.</p>

Damaged Gutter

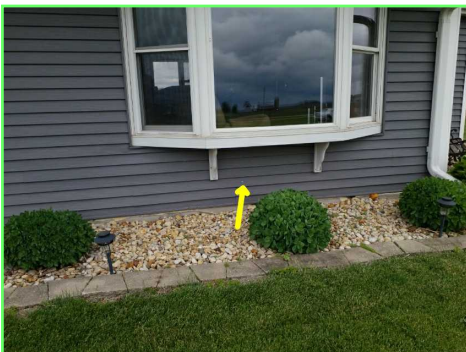
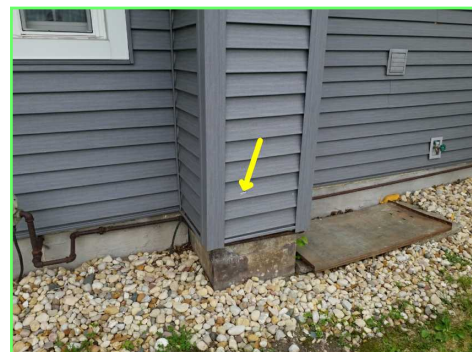
1.1. Holes were observed in the siding. This condition could allow water to get behind the siding and penetrate the interior walls causing damage. Unable to determine the condition of the underlying material.

Hole in Siding

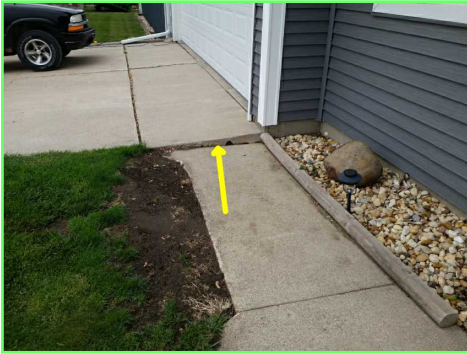
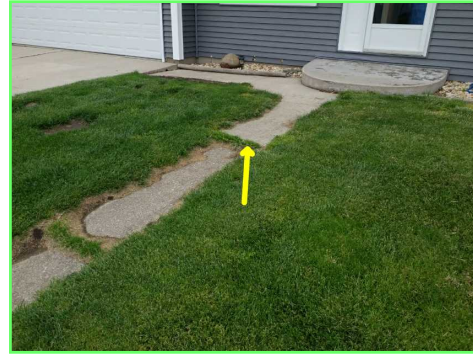
6.1. The front sidewalk has settled and/or heaved and presents a possible trip hazard. This condition should be altered for improved safety. Recommend a qualified concrete contractor or qualified mud-jacking company be consulted for repair or replacement options.

Uneven Walkway

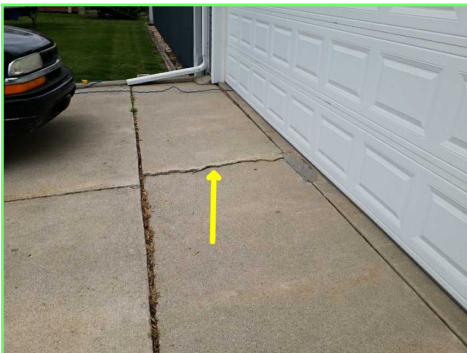
7.1. Portions of the concrete driveway has heavy cracking and displacement. This is a potential tripping hazard and should be corrected for safety reasons.

Cracking In Driveway

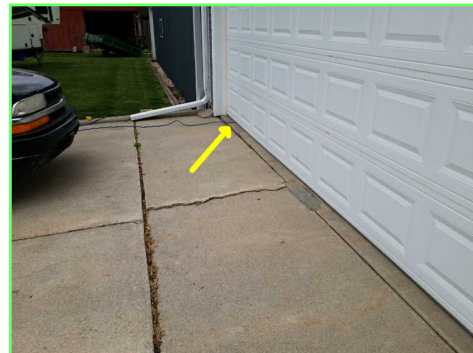
7.2. The driveway has settled where it meets the garage floor and presents a possible trip hazard. This condition should be altered for improved safety. Recommend a qualified concrete contractor or qualified mud-jacking company be consulted for repair or replacement options.

Settled At Garage

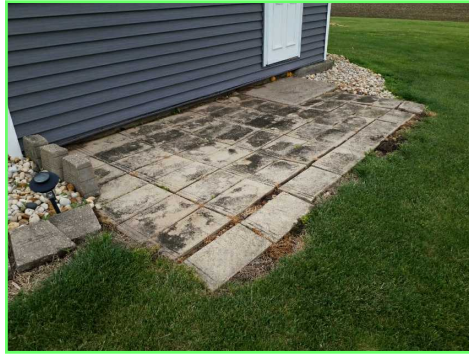
13.1. The block patio has settled and heaved. Recommendation is to have a specialist provide an estimate for repair or replacement.

Blocks Have Settled

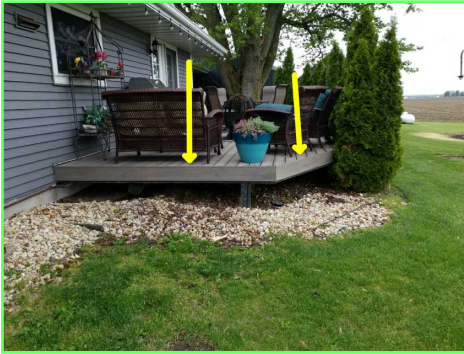
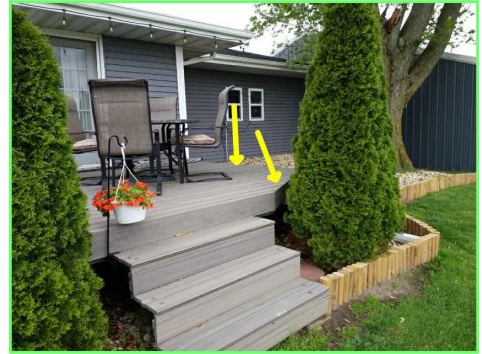
14.5. **Safety Concern**: As there is a danger of falling, a railing needs to be provided for the deck. By today's standards, balusters (spindles) should be spaced no more than 4" apart for the safety of small children, guardrails need to be at least 36" in height and be able to withstand 200 lbs. of force. Railings are required on all decks over 30 inches from the ground. Recommend a **qualified deck specialist** be consulted for repairs.

No Railing Present

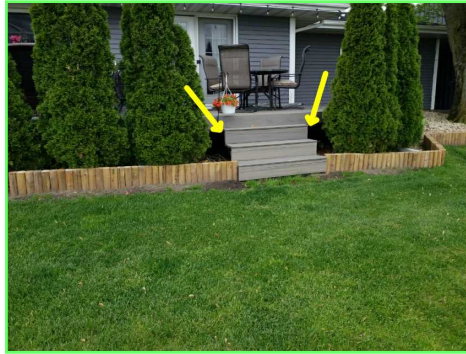
14.4. **Safety Concern**: As there is a danger of falling, a railing needs to be provided for the deck stairs. By today's standards, balusters (spindles) should be spaced no more than 4" apart for the safety of small children and guardrails need to be at least 34" in height, measured from the nose of the stair tread. The top of the railing also needs to be graspable. Recommend a **qualified deck specialist** be consulted for repairs.

No Handrail Present

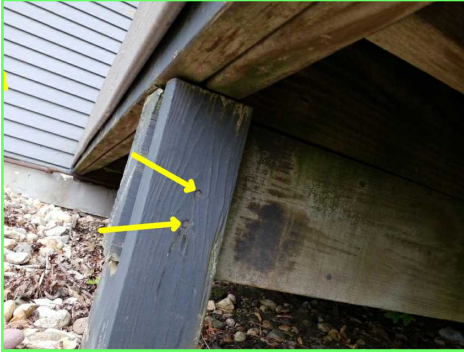
14.3. **Safety Concern**: The support posts for the deck are not properly attached to the deck. Recommend a **qualified deck specialist** be consulted for **further evaluation** and repairs.

Post are Not Properly Secured

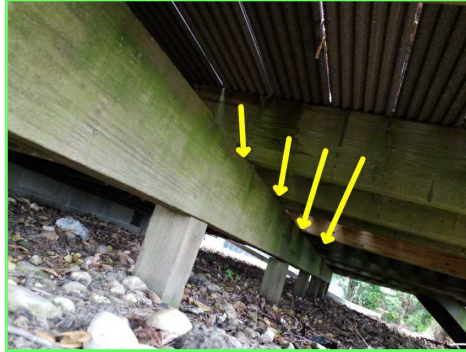
14.2. **Safety Concern**: The deck floor joists are not properly secured to the framing. This is a common problem with deck construction that can lead to failure of the deck. The joists should be secured to the framing with the proper hangers. This is important for **shear strength** under heavy loads. Recommend a **qualified deck specialist** be consulted for **further evaluation** and repairs.

Floor Joists Not Secured Properly

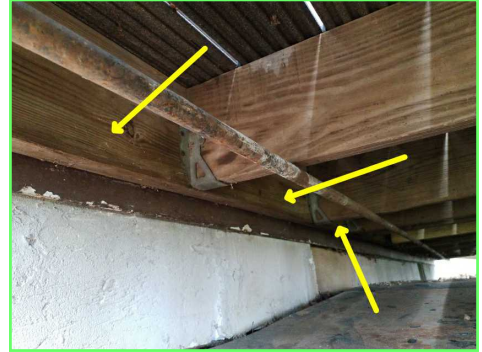
14.1. **Safety Concern**: The deck does not appear to be properly secured to the house. This is a common problem with deck construction that can lead to failure and collapse of the deck. The ledger board should be lag bolted (with the proper length lag bolt) or through bolted to the building correctly. Recommend a **qualified deck specialist** be consulted for **further evaluation** and repairs. For more information click [HERE](#) or search the web for deck failures.

Not Properly Secured to House

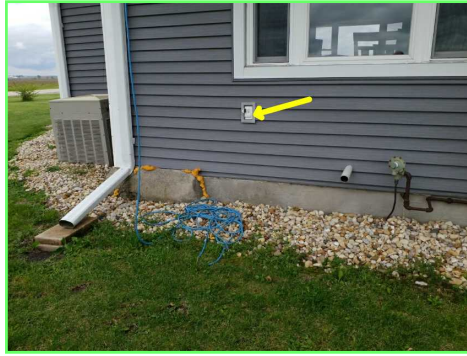
15.1. **Safety Concern**: Ungrounded 3-prong outlets were observed. These outlets should also be fitted with a Ground Fault Circuit Interrupter (**GFCI**) outlet, as it is an exterior outlet. Recommend a qualified electrician be consulted for **further evaluation**, repairs and check for other repairs that may be needed at that time.

Un-grounded 3 Prong

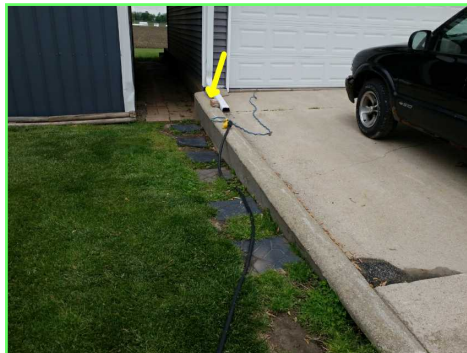
17.1. The retaining wall was observed to be showing signs of movement. This condition should be monitored. It is impossible to determine the rate of movement during a one-time visit to the home.

Movement Of Retaining Wall

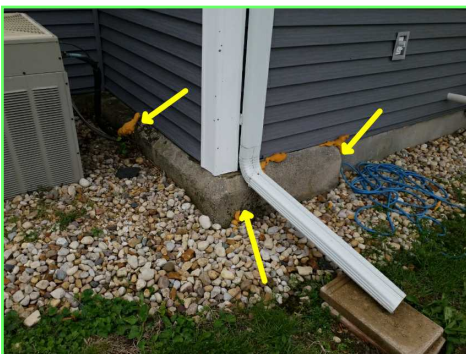
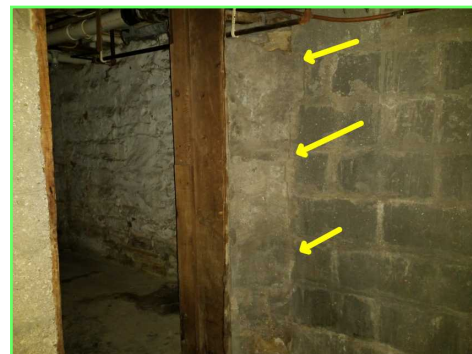
2.1. Settlement and/or shrinking cracks were observed in the **foundation** walls in the basement. This implies that some structural movement of the building has occurred. Cracks of this type should be monitored for any sign of additional movement. [More information on foundation cracks](#)

2.2. Settlement and/or shrinking cracks were observed in the **foundation** walls on the exterior. This implies that some structural movement of the building has occurred. Cracks of this type should be monitored for any sign of additional movement. [More information on foundation cracks](#)

Cracks In **Foundation**

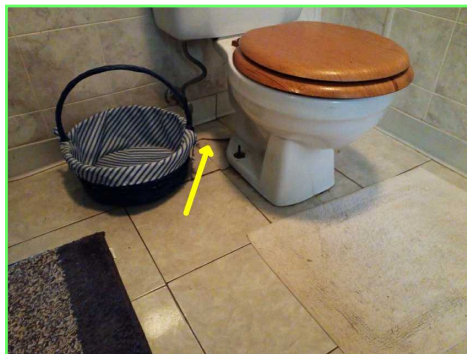
2.1. The tile floor is cracked around the toilet in the main floor three quarter bathroom. The flooring was also observed to be showing signs of weakness.

Cracked And Weakness

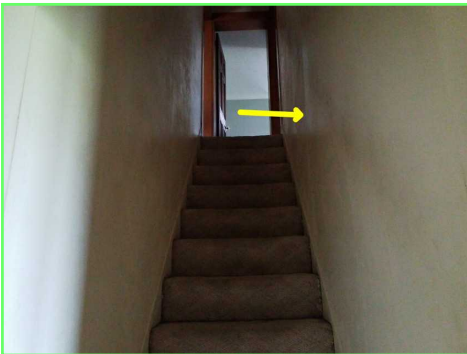
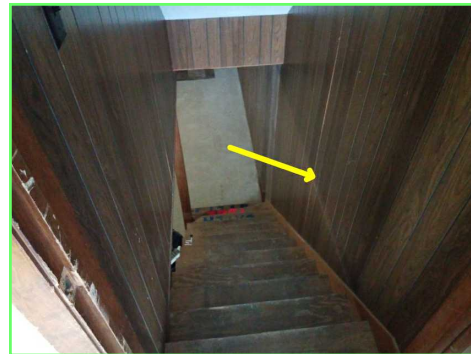
5.1. **Safety Concern**: A handrail needs to be provided for the second floor, and, basement stairway.

No Handrail Present

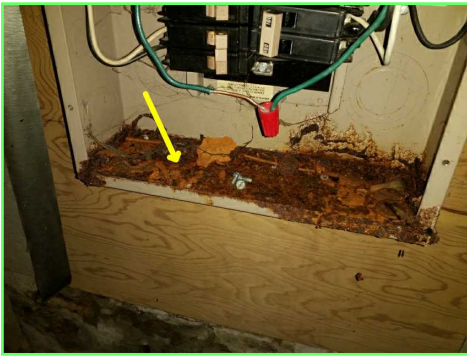
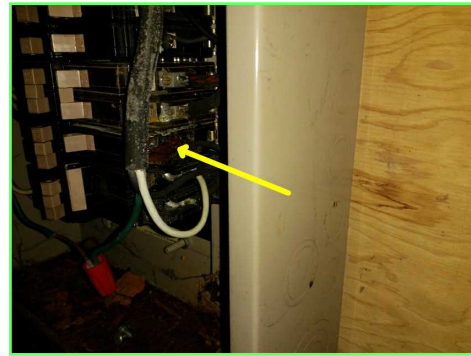
5.1. The main distribution panel showed evidence of rusting, suggesting the presence of moisture. This area should be monitored. If rusting continues, or if moisture is evident in the vicinity of the panel, a qualified licensed electrician should be consulted.

Rusting

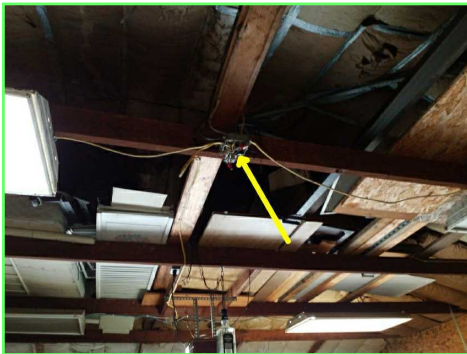
Covers Missing

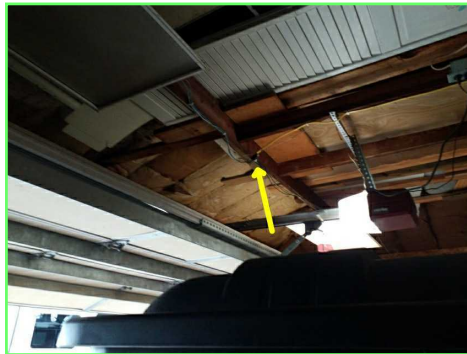
No Junction Box Present

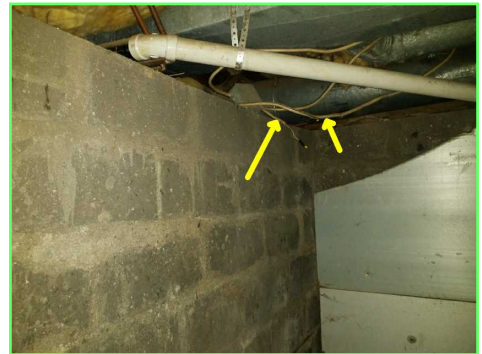
Abandoned Wiring

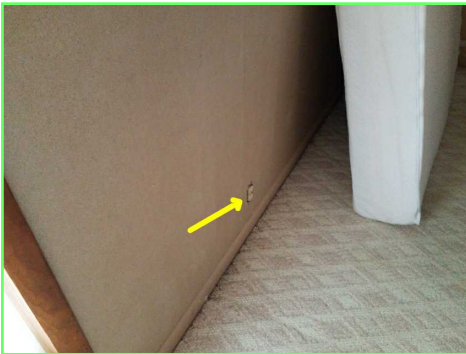
9.2. Missing outlet cover plates should be replaced to avoid a shock hazard.

Missing Cover

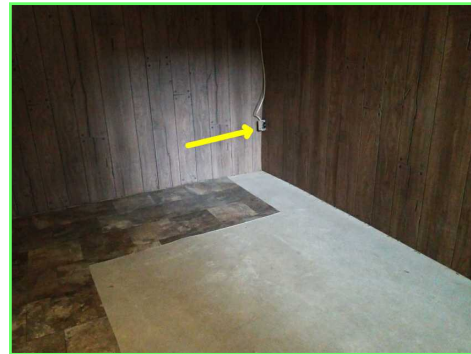
9.1. The extremely loose outlet(s)/receptacle(s) in the basement should be repaired or replaced.

Loose Outlet

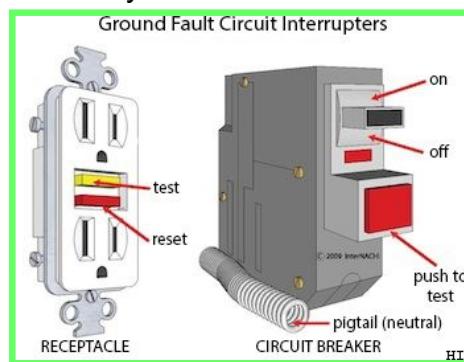
10.1. The installation of Ground Fault Circuit Interrupter (**GFCI**) devices are missing at the Kitchen Sink, Quarter Bathroom, Main Floor Three Quarter Bathroom, and, , Main Floor Full Bathroom outlets. This should be corrected for safety reasons.

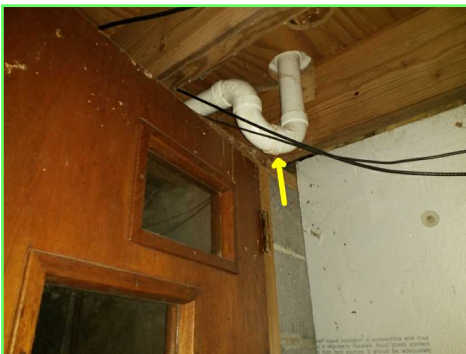
6.2. The waste piping is leaking in the Basement.

Leak Observed

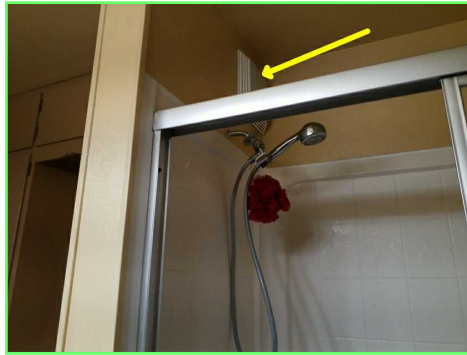
7.2. **Safety Concern**: The light and fan that is installed on the wall above the shower head is not a water proof fixture. This should be corrected for safety reasons.

Not Water Proof

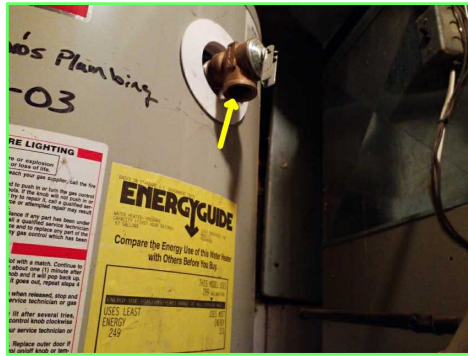
18.1. **Safety Concern**: The discharge piping serving the Temperature and Pressure Relief Valve (**TPR**) for the water heater was missing. The piping should terminate not less than 6 inches or more than 24 inches above the floor.

TPR Vent Pipe Missing

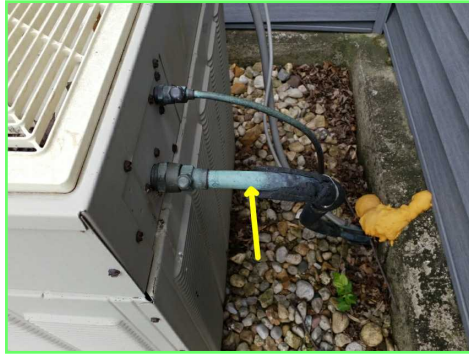
5.1. Damaged insulation on refrigerant lines should be repaired. This is very critical in the efficiency of the cooling system.

Damaged Insulation on Refrigerant Line

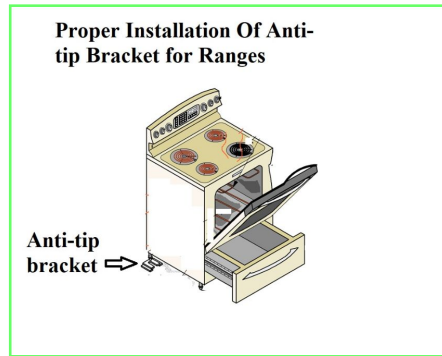
4.1. Anti-tip bracket is missing from range installation. See label inside oven door. All free-standing, slide-in ranges include an anti-tip device and is essential in the safe operation of the range. It provides protection when excess force or weight is applied to an open oven door. Anti-tip devices became a UL (Underwriters Laboratories) safety standard in 1991.
